SCOPE OF WORK
STABILIZATION REPAIRS AT THE SWAN HOTEL
SOUTH QUEEN AND VINE STREETS, LANCASTER, PA

Subject: Swan Hotel Exterior Wall Assessment
Project No: 02235

Subject: Swan Hotel Exterior Wall Assessment
Project No: 02274

Subject: Swan Hotel Conditions Assessment
Project No: 02274

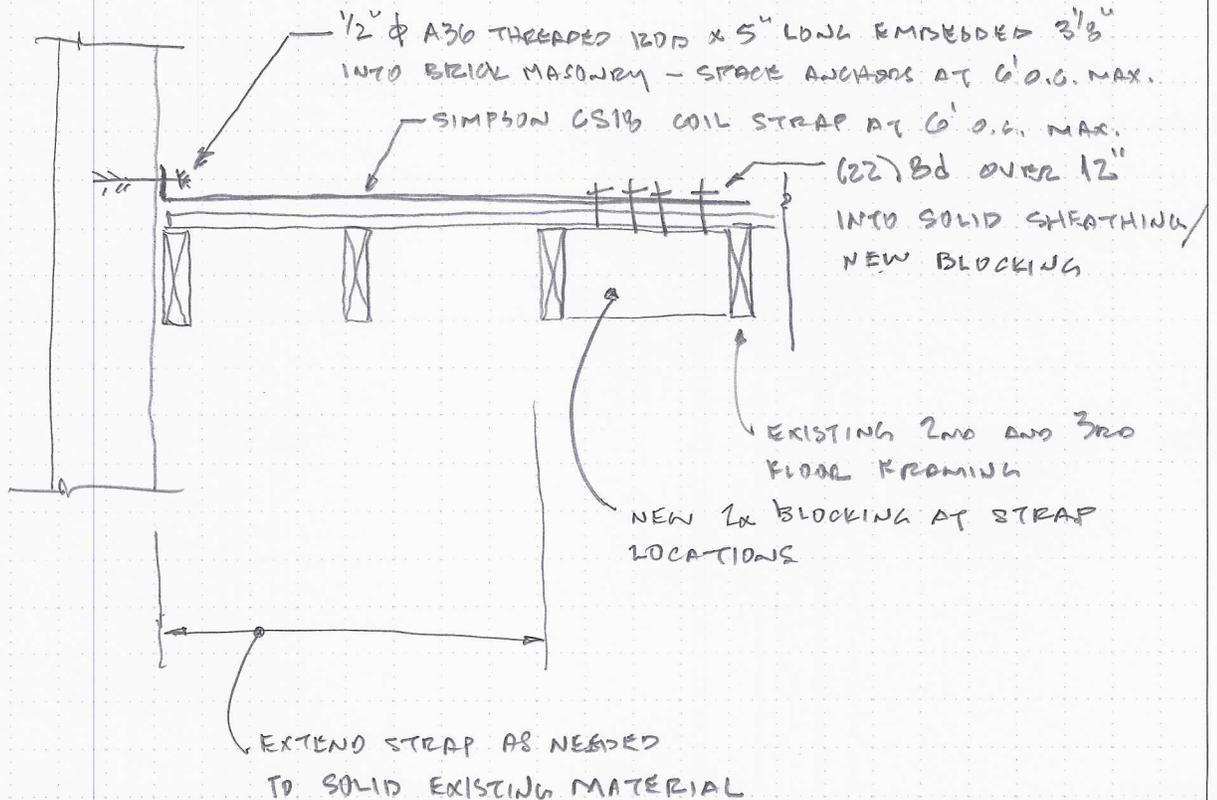
The condition of the exterior brick is in relatively acceptable condition, with the exception of the brick at the southeast corner. The wall is approximately thirty feet high, extending from grade to the third floor ceiling line, and to the roof eave/parapet. The wall is out of plumb approximately two inches over the height. The wall is essentially bowed to the south between the ground floor and third floor ceiling.

CS10 = $T_A = 1370 / 1.6 = 856$

SPACE STRAPS = $856 / 147 = 5.82' \rightarrow 6' \text{ O.C. MAX.}$

I do not recommend attempting to force the wall back to plumb. The wall is currently stable and can remain so by tying it into the second and third floor framing levels. I have attached a sketch with a tie system that should be placed at the southeast corner and at least two more locations to the west. The corner tie can be within two feet of the corner, the remaining two locations shall be at no more than six feet centers.

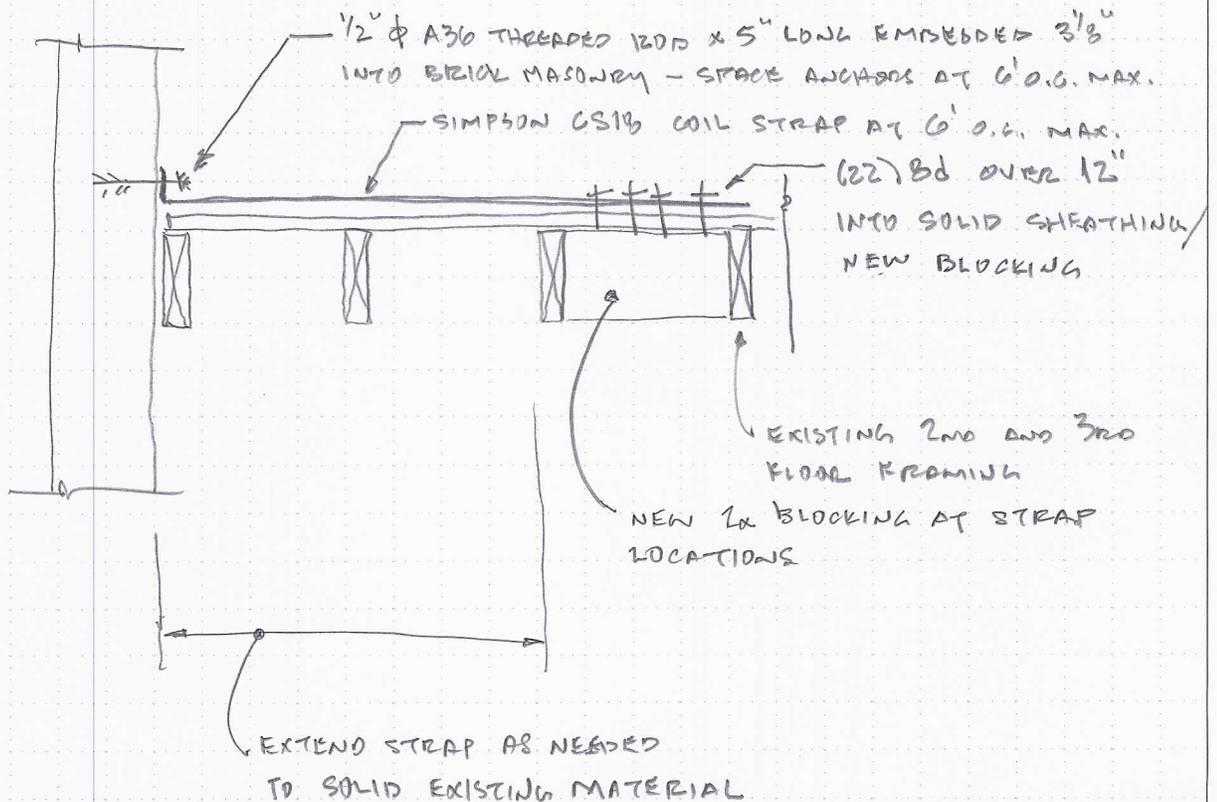
The condition of the exterior brick is in relatively acceptable condition, with the exception of the brick at the southeast corner. The wall is approximately thirty feet high, extending from grade to the third floor ceiling line, and to the roof eave/parapet. The wall is out of plumb approximately two inches over the height. The wall is essentially bowed to the south between the ground floor and third floor ceiling.

CS10 = $T_A = 1370 / 1.6 = 856$

SPACE STRAPS = $856 / 147 = 5.82' \rightarrow 6' \text{ O.C. MAX.}$

I do not recommend attempting to force the wall back to plumb. The wall is currently stable and can remain so by tying it into the second and third floor framing levels. I have attached a sketch with a tie system that should be placed at the southeast corner and at least two more locations to the west. The corner tie can be within two feet of the corner, the remaining two locations shall be at no more than six feet centers.
